URGENT MEDICAL DEVICE SAFETY INFORMATION AND CORRECTION

Defibtech DDU-100 Series AEDs

March 11, 2011

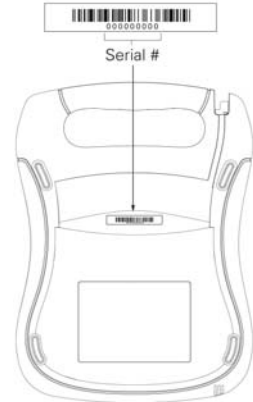
- 1) Remove the pads from the storage pouch found on the back of your DDU-100 series AED and inspect the 9-digit serial number label. See illustration for location of the 9-digit serial number label.

- 2) Carefully note the 9-digit serial number on the back of the AED, then visit the Defibtech website at www.defibtech.com/fa11 and enter your serial number(s) to determine if your AED is affected by one or both of the conditions described above. Alternately, please email your serial number and contact information (name, address and email) to fa@defibtech.com, or call Defibtech directly at 1-877-453-4507 or 1-203-453-4507, and Defibtech will inform you if your unit is affected.
